**LAKE TAPAWINGO DAM
JACKSON COUNTY, MISSOURI
MO. 20127**

PHASE 1 INSPECTION REPORT NATIONAL DAM SAFETY PROGRAM

BLACK & VEATCH
CONSULTING ENGINEERS
KANSAS CITY, MISSOURI

AUGUST 1978

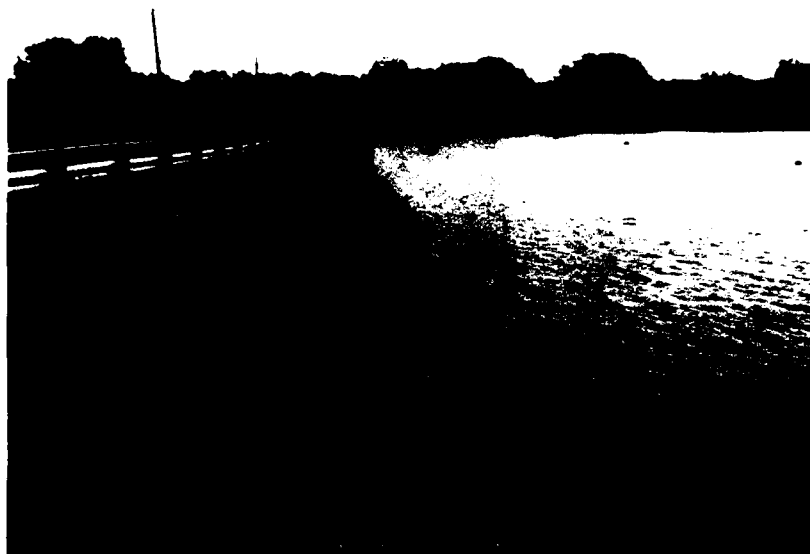
b. Dam. The inspection team observed the following items at the dam. The upstream slope above the water level is very steep. The riprap has been covered with asphalt. Voids were observed between the riprap in several areas but their extent and severity could not be determined due to the asphalt overburden. A crack in the asphalt overlay was observed at the junction of the crest and the upstream slope of the dam, however, it could not be determined if the crack extended deeply into the embankment material. Seepage through the embankment was observed at several locations. The observed seepage did not indicate that piping was occurring. Minor seepage was observed at the junction of the dam and the left natural abutment material. Sloughing of the embankment was observed about 200 feet right of the left abutment. The sloughing was probably the result of erosion near the toe of the dam caused by discharges from the emergency spillway. There were numerous small trees and a heavy stand of weeds on the downstream slope.

PHOTO 1: UPSTREAM FACE OF DAM (LOOKING EAST)

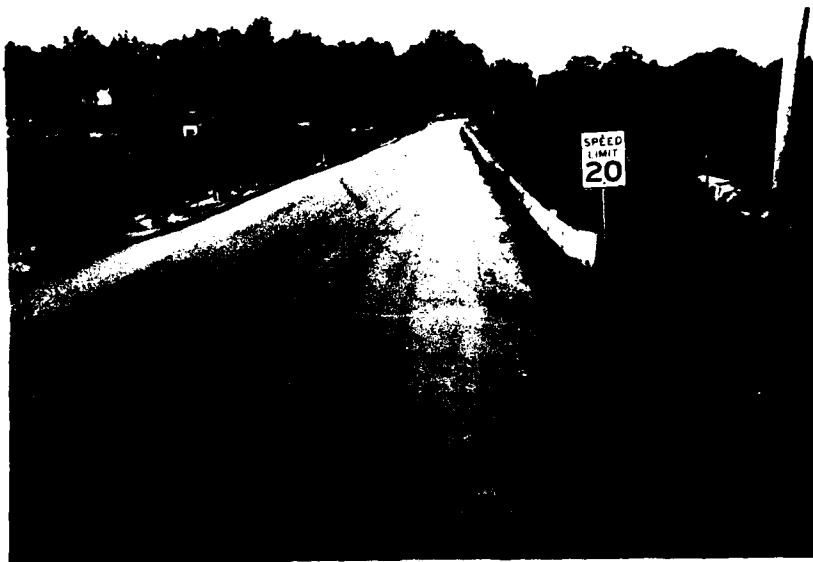
PHOTO 3: CREST OF DAM (LOOKING WEST)
